# CHARACTERIZATION AND PROPOSALS FOR RECOVERY OF TRADITIONAL TAMANG CONSTRUCTION IN NORTHERN NEPAL

**KEY WORDS:** Nepal. Tamang. Seismic Risk. Stone construction. Timber structures

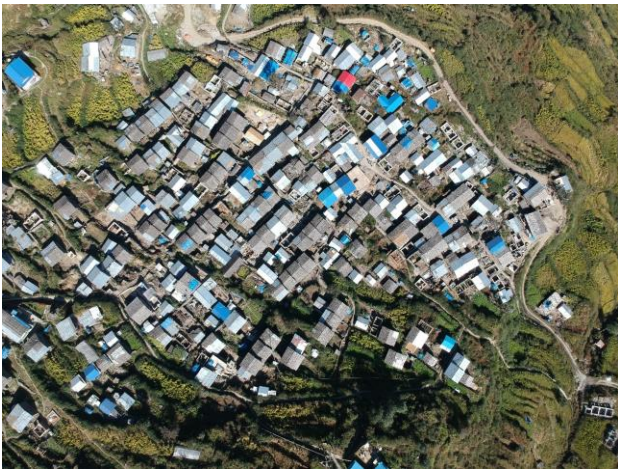
Figure 1. Aerial view of Gatlang (Álvaro Rodríguez. UEM student)

In the town of Gatlang the urbanization presents a very clear order (although with an irregular and winding layout) in rows of terraced and staggered houses in the direction of the maximum slope of the hill, descending in the northeast direction (Figure 1). The houses are usually built on horizontal terraces where groups of three to five detached houses are located. The slope does not favor facades facing south, so the main openings in the houses face to the southeast, with ample space between one row and another, permitting solar gains (Figures 2 & 3).

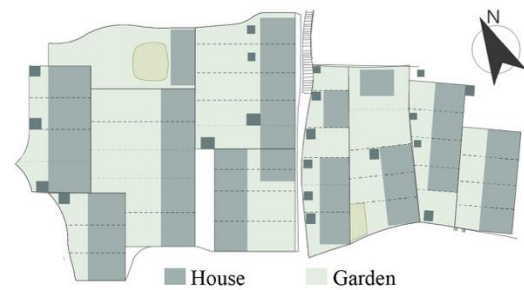
Figure 2. Detailed distribution of houses and open-air areas. Plan view (Authors)

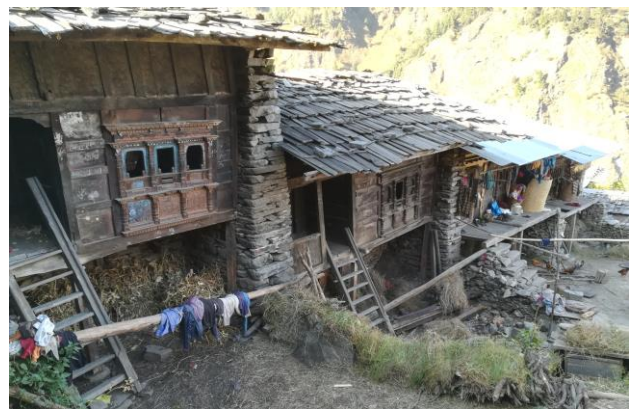
Figure 3. Group of staggered housing (Authors)

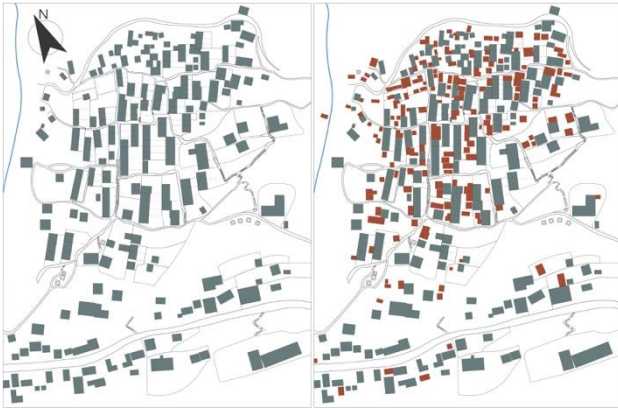
Figure 4. Left map - Gatlang traditional houses – Right Map. 2016- Gatlang traditional houses and makeshift dwelling marked in red. 2019 (Authors)

Many of the passageways are still blocked by debris and the village is in process of general reconstruction. Over the last three years, provisional housing has been converted into definitive brick and concrete housing thanks to the help of the government and international organizations however, they have not promoted the conservation of the typical typologies of traditional architecture (Figure 4).

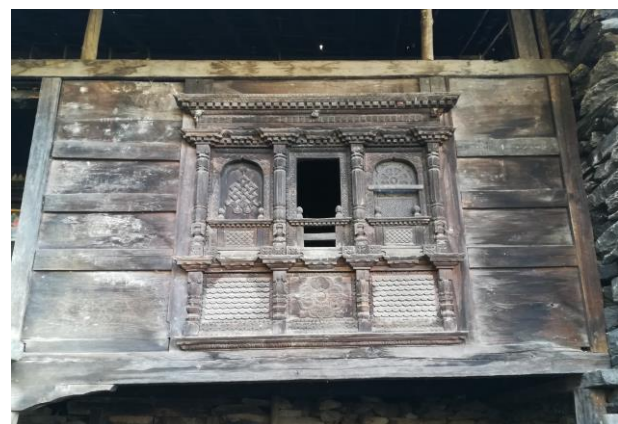
Figure 9. Wood facade (Authors)

**2.1.3 Special constructive elements (façade wooden panels):** As a closing of this framework, on the main facade, a fine carpentry work is carried out, with assembled pieces, more typical of joinery than timber crafts. Panels between 40 and 50 cm wide form the facade, joined by slats of 10 to 12cm wide, which are interrupted to place the main sculpted piece with the openings and shutters. All of the houses have these fronts with a strong symbolic character. The fronts are made up of one or three pieces and have wood engravings that makes them very unique within the architecture of the village (Figure 9).

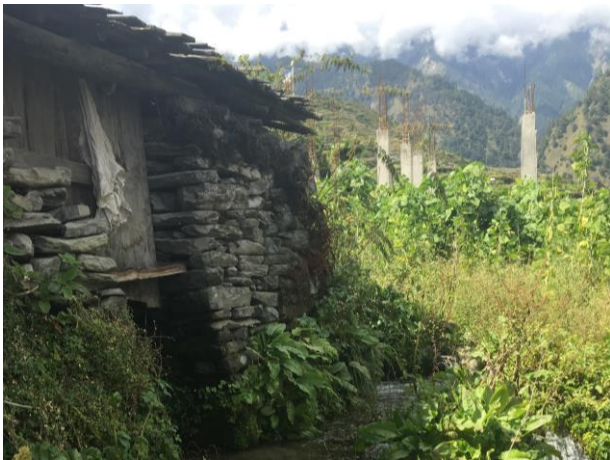
Figure 10. Downstream façade of a mill (Authors)

**2.2.2 Description of the construction and structural system:** The buildings of the mills follow the general scheme of the dwellings previously exposed but clearly they have a simpler construction, less cared and it seems one of the causes of their fast deterioration (figure 10)

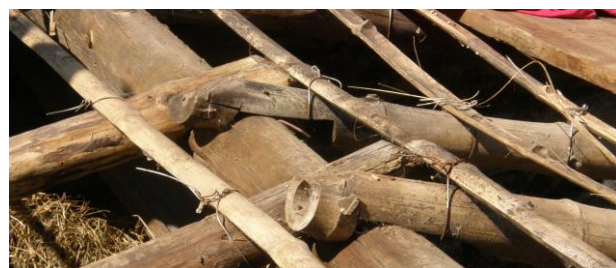
Figure 12. Constructive elements and ridge beam (Authors)

The base is a rectangle (or "L" shape sometimes) of stone that starts at the water level, where the propeller is hosted, and rises up to the ground floor, where the grinding machinery is placed. This perimeter of the stonewalls has an open area where the water comes in. It is built with a wooden beam and a wooden board enclosure over it. On the ground level, a wooden floor is supported by the edge beam and an interior wall. The floor occupies only half of that surface, which is necessary to cover the passage of water and the propeller (figure 12)

The gabled roof consists of a wooden beam, which has the span of the floor longest size, supporting bamboo joists, which form the slope. Other bamboo sticks are arranged in a disorganized way between the joists to support the timber tiles. In some mills, a column is placed reducing the span of the beam. There are no bracings in the plane of the ridge beam, which makes the roof structure very unstable lengthwise.

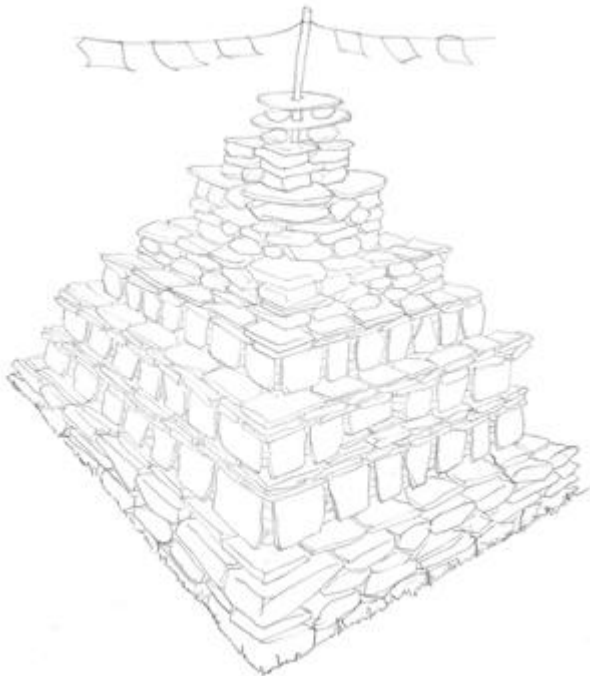
Figure 13. Axonometric drawing of stone chorten (Authors)

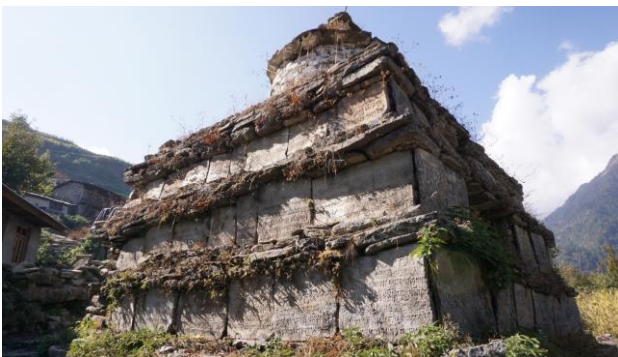
Figure 14. Chorten in Gatlang (Authors)

**2.3.1 Description and use:** The chortens are one of the most characteristic religious constructions in Buddhism; one of their translations of Tibetan is “receptacle of faith” as a sign of the spirit. Its origin is in the Stupas, ancient Indian tombs where Buddha was buried, so it is believed that the first of the chortens kept the remains of Buddha. Today they usually contain religious texts, relics or objects of a holy lama or someone of importance within the community. It is because of this Hindu origin, and its subsequent use in Buddhist culture, that the chorten can be found throughout Asia. This expansion across the continent leads to many variations in its construction from one region to another, but all of them maintain a number of concepts regarding their geometric composition (Figures 13 and 14) and symbolism as a representation of the path to “awakening”. Its construction or subsequent restoration is considered of great value to those who do it. As in other religions chortens should be surrounded clockwise, the circumambulation of a chorten is called Kora (Tibetan) in reference to the peregrinations to sacred places in Tibet. According to Buddhism, performing this exercise helps in meditation and achieve the desired wishes

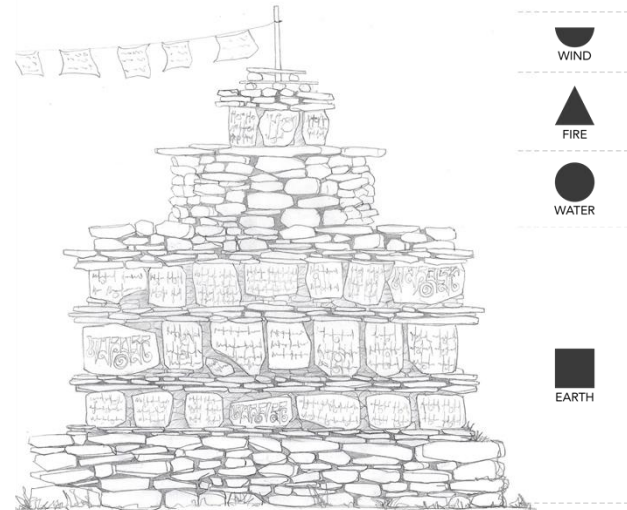
Figure 15. Front view of stone chorten (Authors)

In Gatlang it is very common to find chortens, when making trips to other places, such as temples or neighboring villages, and within the village, chortens are considered of great value within the community and have many unique characteristics compared to chortens found in other areas. Most of chortens consist of five parts that symbolize aspects of Buddhism and Hinduism such as the five elements of the universe (Figure 15) or the Buddhas of meditation. Gatlang chortens have fewer parts due to their simpler construction.

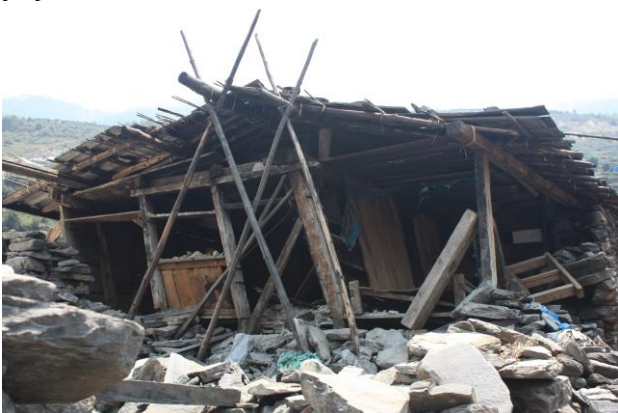
Figure 17. Collapsed house 2016 (Authors)

**3.1.1 Observation of damage on buildings after the earthquake:** The structures of the Tamang buildings are clearly differentiated between the stone perimeter walls and the wooden framework. The walls formed by stones without mortar have the great problem of crumbling by throwing the stones from the parts with less vertical load such as the gables. Besides the lack of mortar, the irregularity of the stones makes the supports between stones very unstable even before an earthquake and therefore very sensitive to horizontal actions. The wooden structure in most cases has remained standing although deforming greatly due to the lack of vertical bracings. The stone structure has no ductility and suffers from very brittle breakage. The wooden structure however has great ductility, which allows it to resist with great deformations. The interaction between both structures during earthquakes can also produce collapse. It is commonly observed that detached stones have sunk wooden roof structures of the buildings down the slope in their fall. It is also observed less frequently that the oscillatory movements of the wooden structures have hit the stone walls causing their collapse (figure 17)
